Boggs Engineering, LLC  
607 South Alexander Street, Ste 101  
Plant City, Florida 33563  
(813) 747-9100

May 31, 2018  
BBE Project No. 13044.001

RE: Pond Inspection and SWFWMD Certification; Site Inspection and Review of Drainage Issues

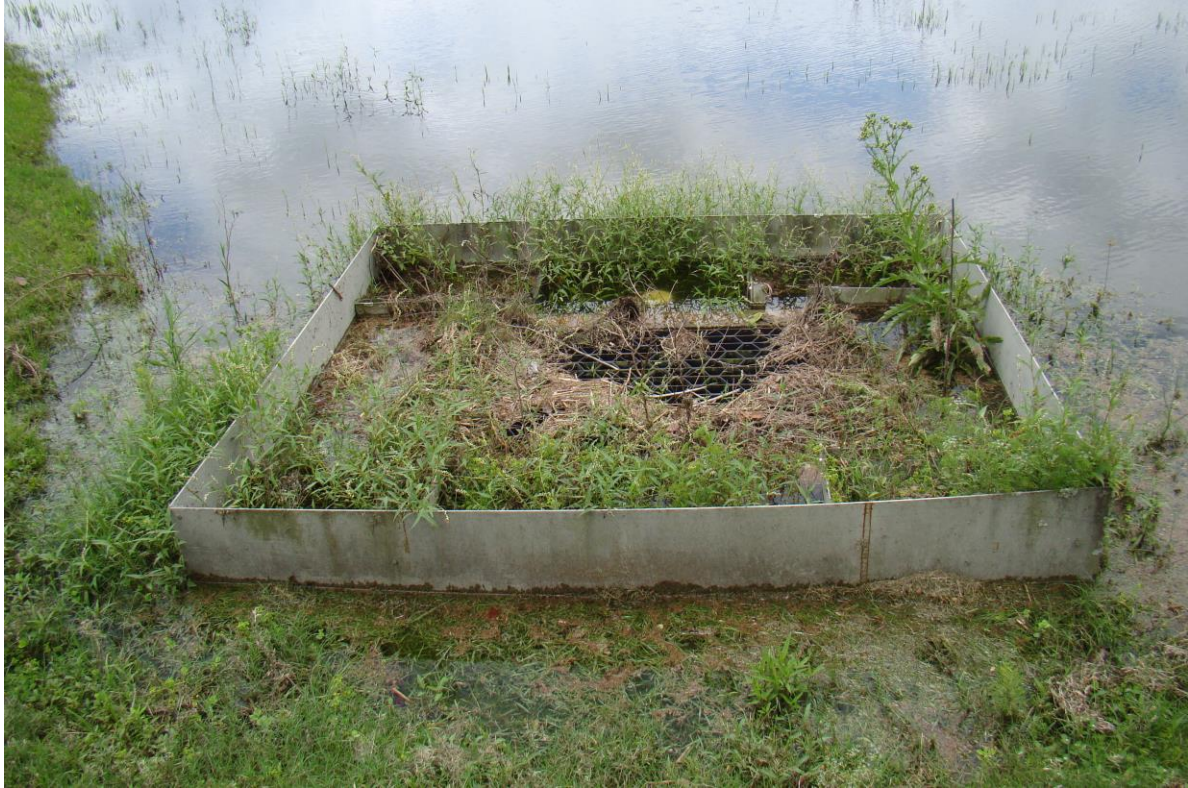
- This pond was in good condition with no large growth in the pond.
- The outfall control structure needs to be cleaned out including all vegetation and trash around and inside of the skimmer.

Image 1: Outfall control structure in Pond N2.

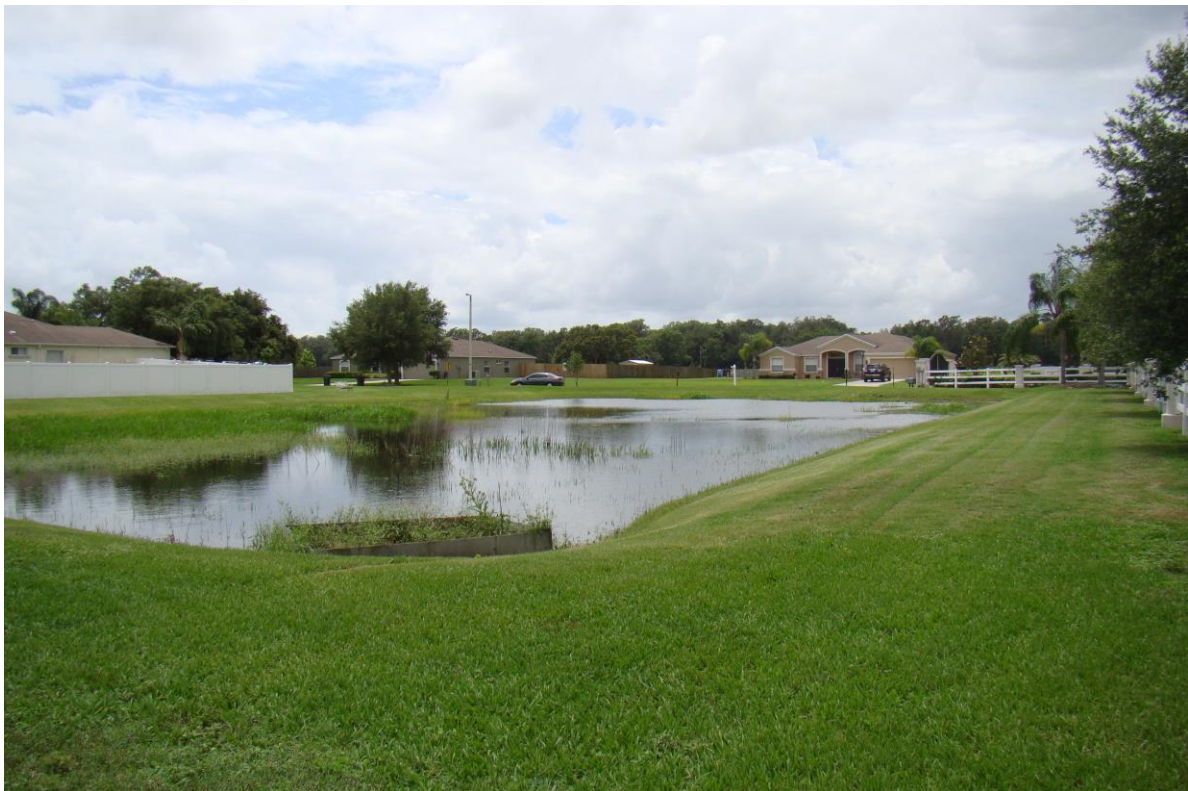
Image 2: Pond N2, standing at northeast corner looking southwest.

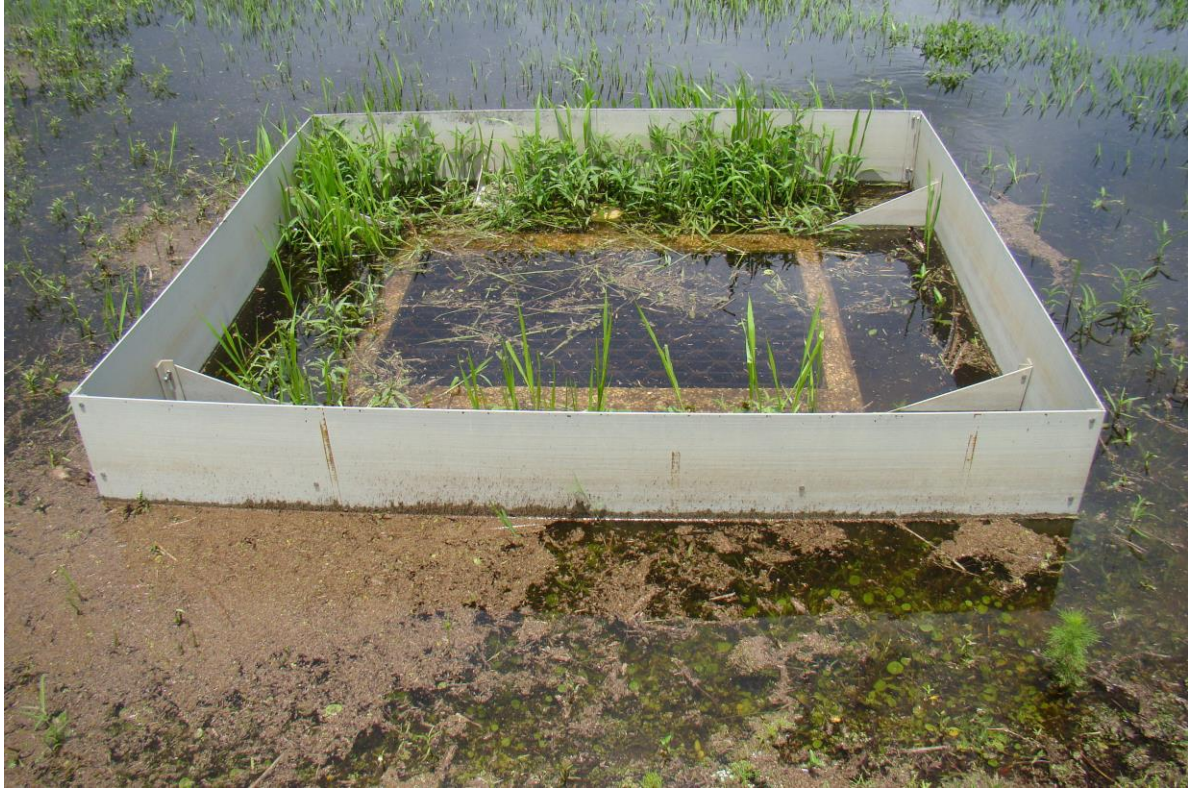
Image 3: Outfall control structure in Pond N.

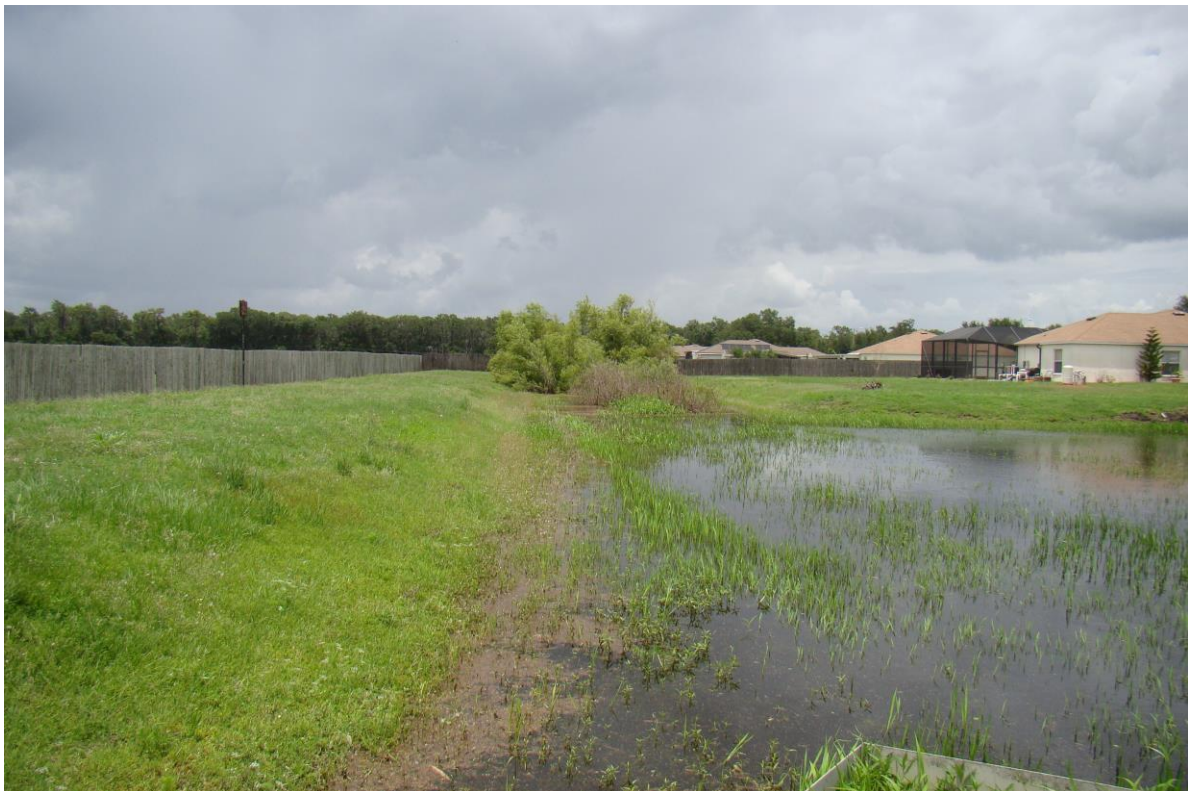
- The outfall control structure needs to be cleaned out including all vegetation and trash inside of the skimmer.
- There is a substantial amount of vegetative growth in the northern half of the pond. This growth needs to be removed from the pond. Should the slopes of the pond be disturbed during the removal of this growth, the disturbed slopes will need to be re-graded to a 4:1 slope and sodded/seeded.
- There is a fence running east-west that spans across the northern portion of this pond. It does not appear this fence will cause conveyance issues as the fence has an opening for water to flow underneath the fence.

Image 4: Pond N, standing at southwest corner, looking north.

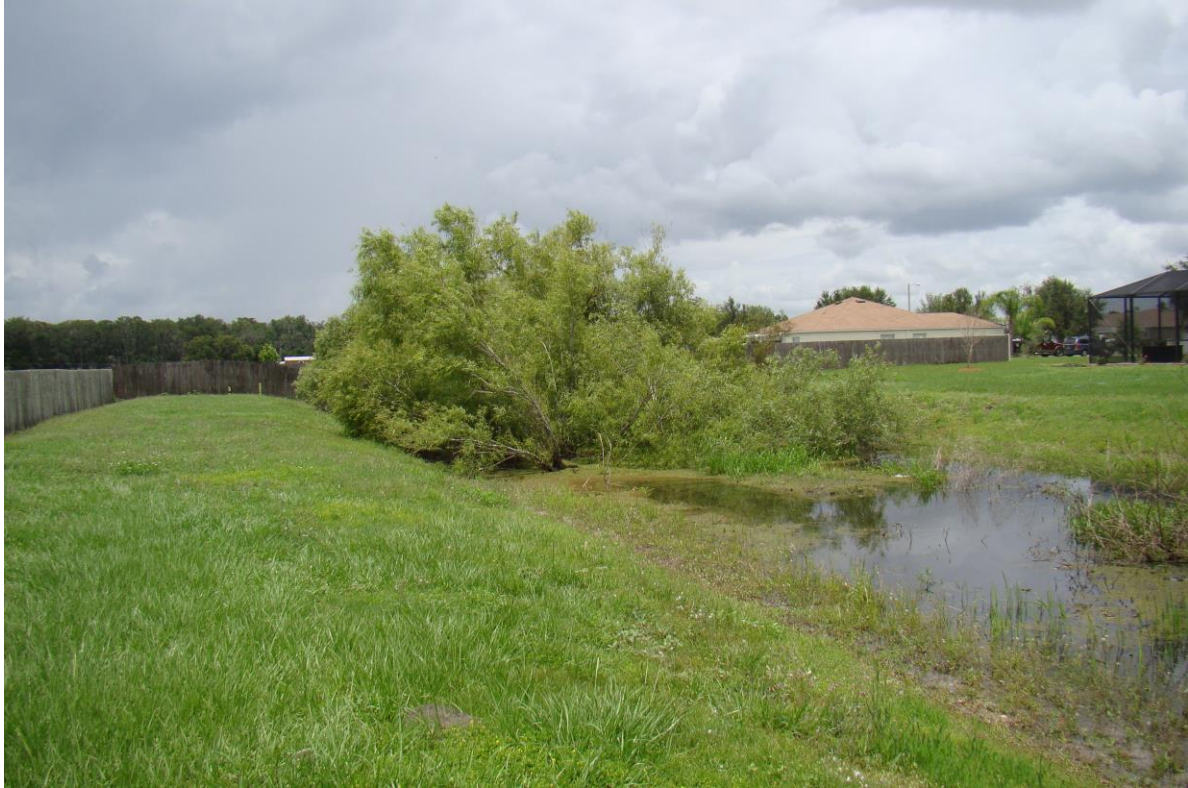
Image 5: Pond N, standing on west side of pond looking north.

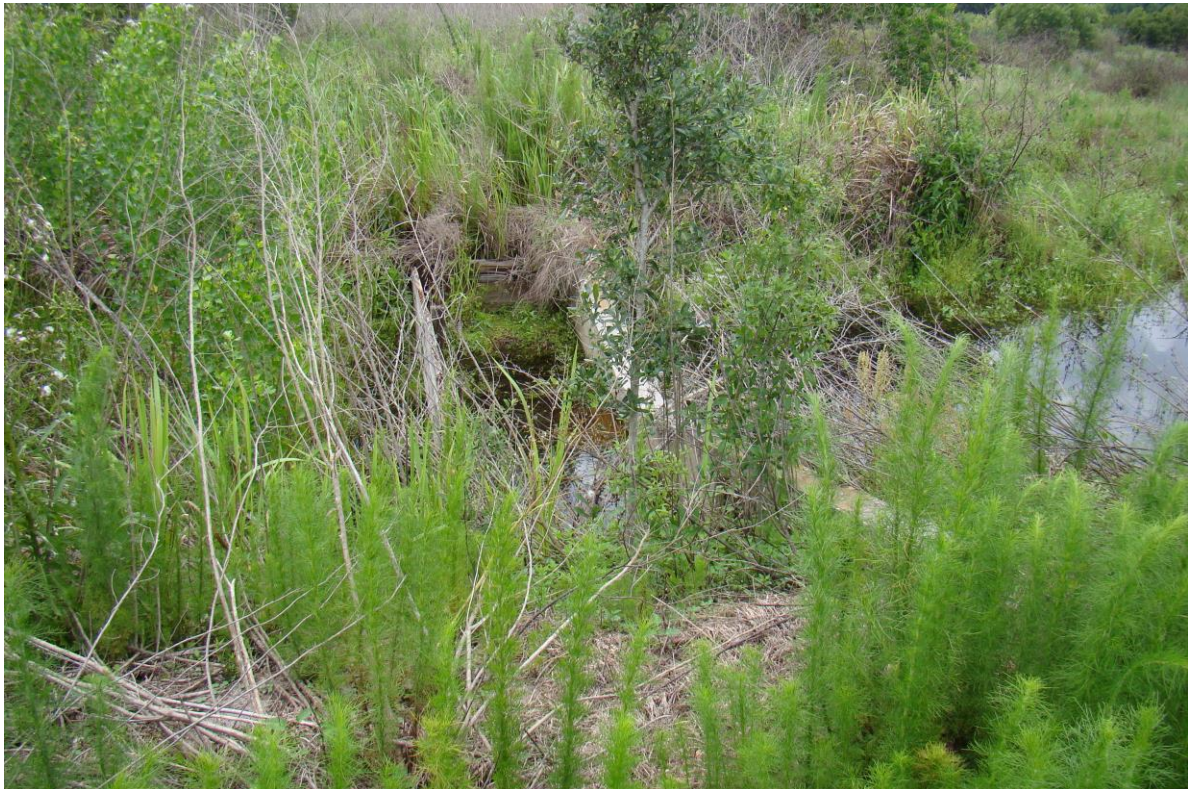
- This pond could not be accessed due to the substantial amount of vegetative growth. The areas that could potentially provide access to the pond were fenced off. The vegetative growth within the pond and the maintenance berm needs to be removed. Should the slopes of the pond or the maintenance berm be disturbed during the removal of this growth, the disturbed slopes will need to be re-graded to a 4:1 slope and sodded/seeded.
- A concrete outfall control structure was found, although the vegetation growth was too large to allow inspection of the structure. The structure is not identified on the permitted plan set.

Image 6: Pond S, concrete control structure found.

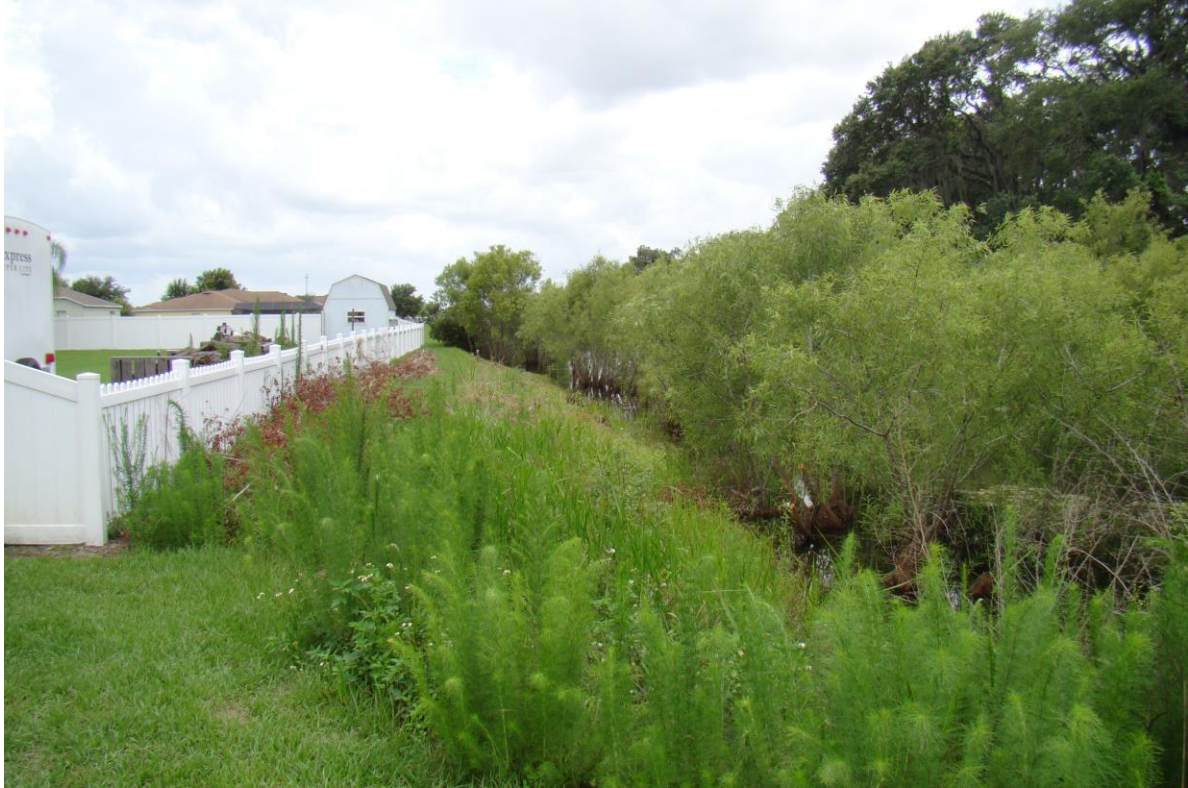
Image 7: Pond S, looking south.

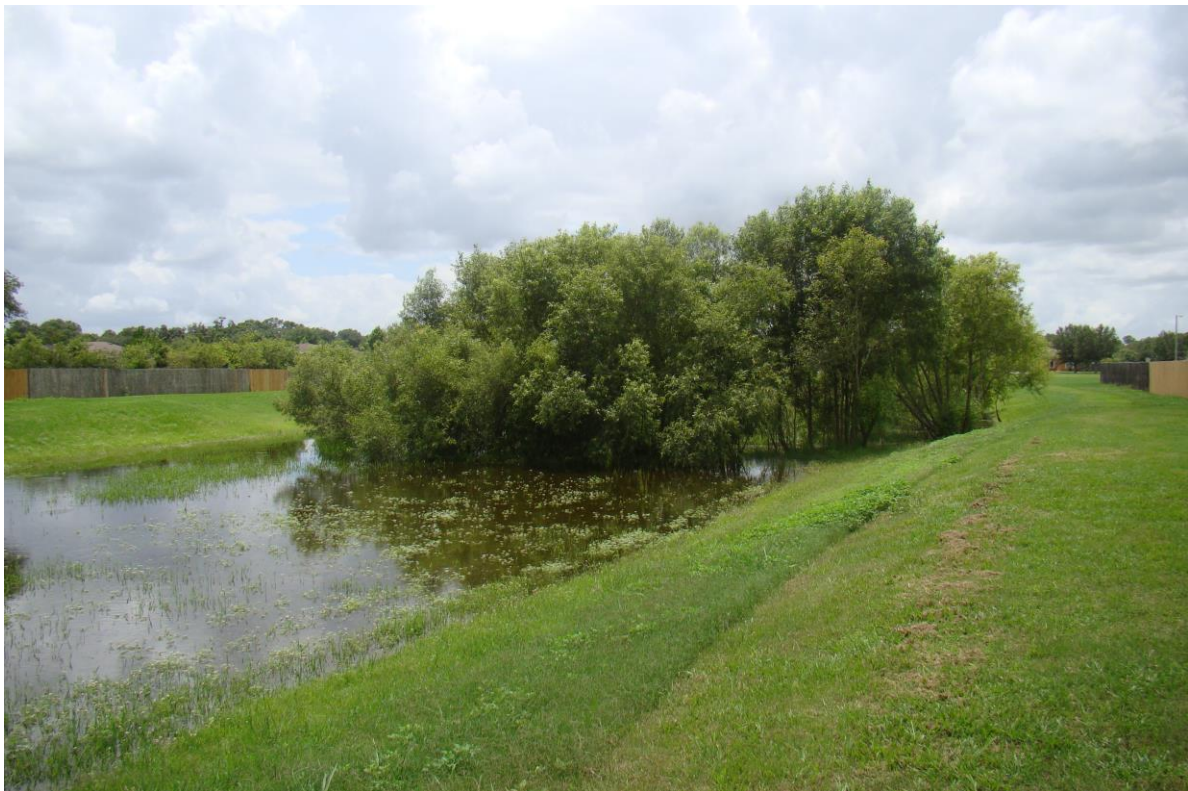
- The western end of the pond has substantial vegetative growth that needs to be removed. Should the slopes of the pond be disturbed during the removal of this growth, the disturbed slopes will need to be re-graded to a 4:1 slope and sodded/seeded.

Image 8: Pond E, standing on northeast side, looking west.

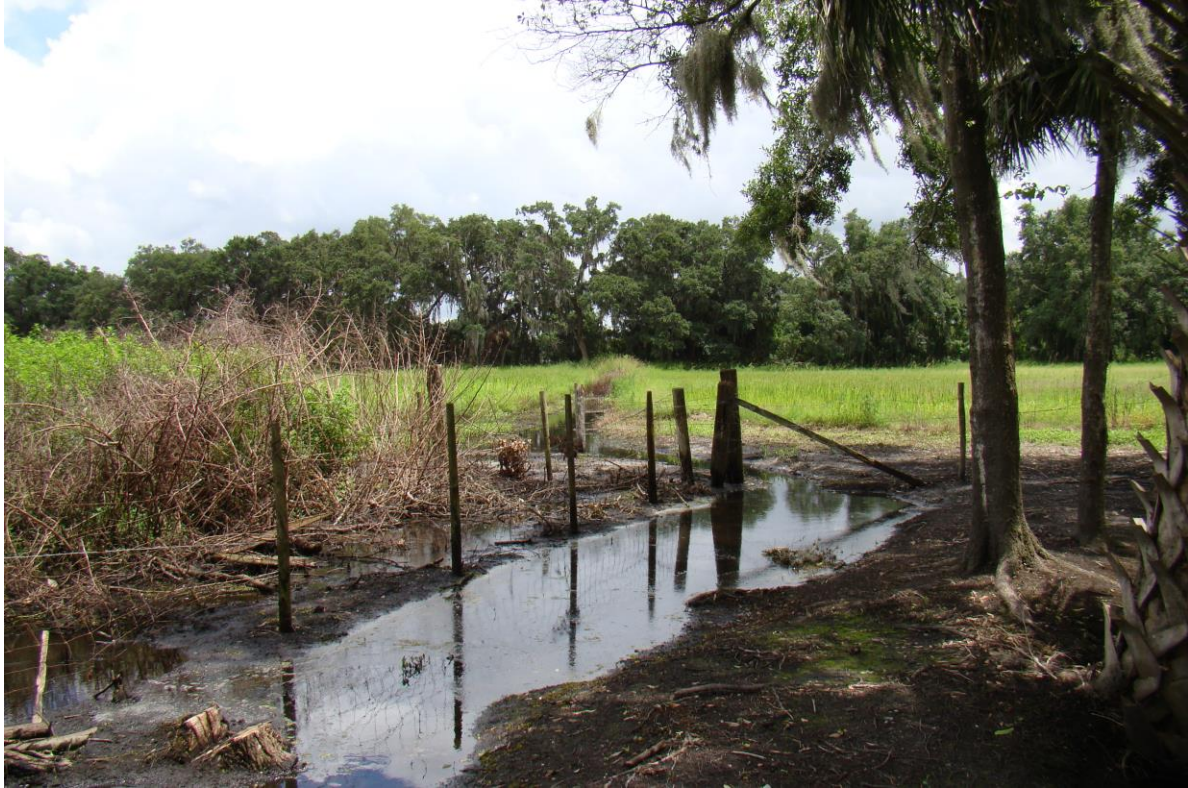
- Per conversations with Mr. Granger, SWFWMD considers this pond to be part of the ERP.
- This pond has a substantial amount of vegetative growth that needs to be removed from within the pond. Should the slopes of the pond or the maintenance berm be disturbed during the removal of this growth, the disturbed slopes will need to be re-graded to a 4:1 slope and sodded/seeded.
- The permitted plan calls for rip-rap around the outfall (S-24) into the pond from Pond E. Per Mr. Granger, he has placed some rip rap; however, rip rap needs to be installed per the plans.

Image 9: Existing pond, standing on eastern side, looking south.

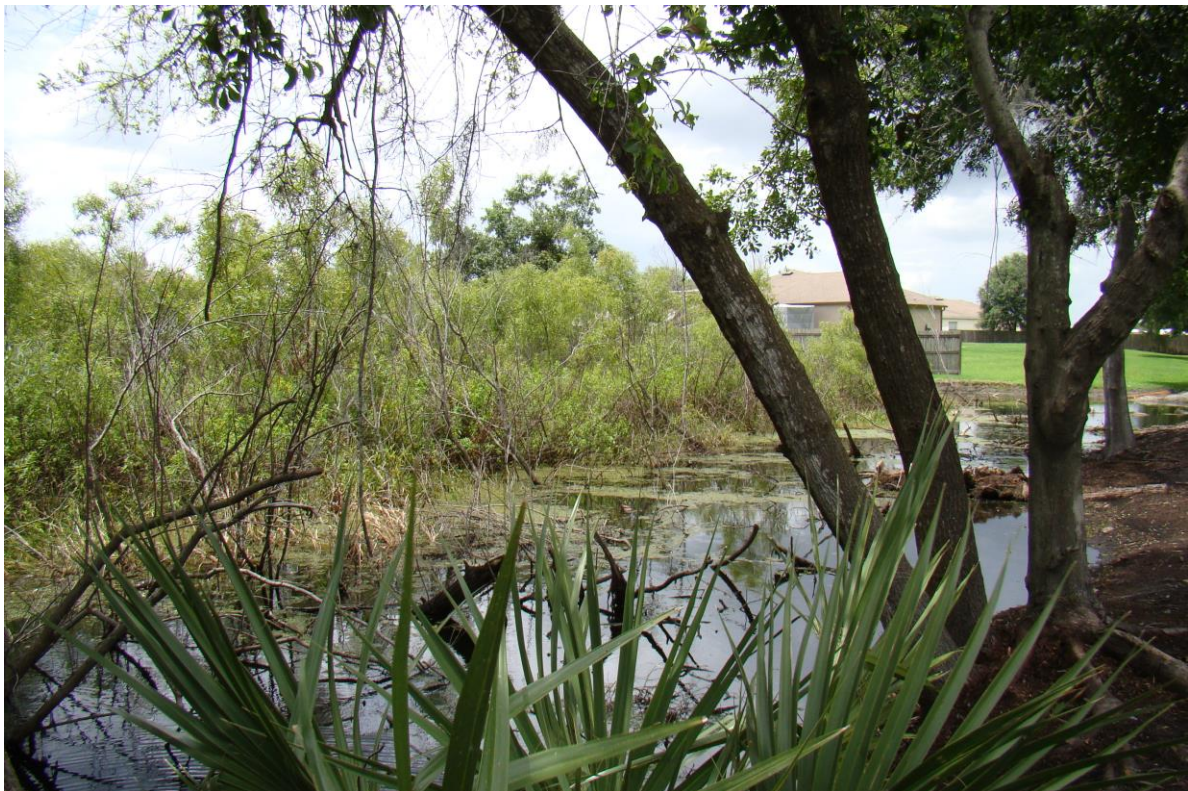
Image 10: Existing pond, standing at southeast corner, looking northwest.

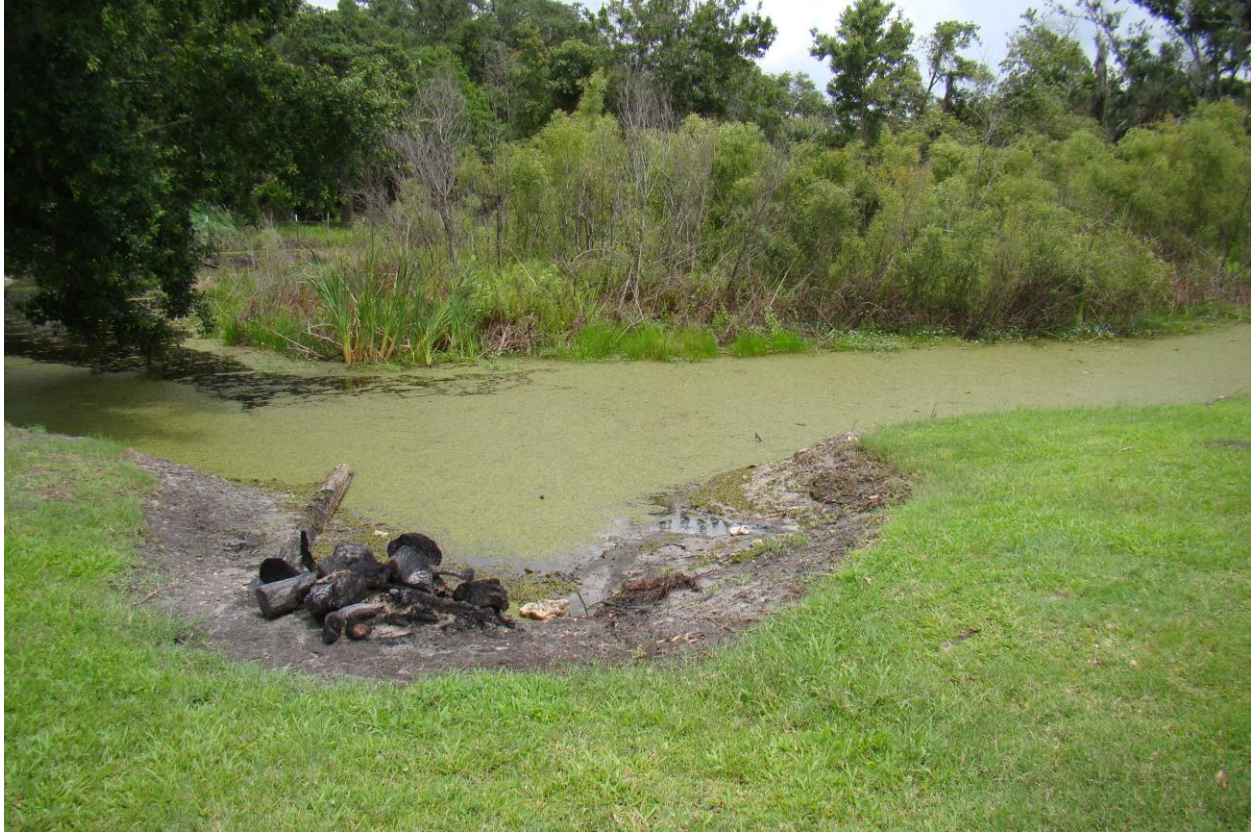
Image 11: Existing pond, standing at northwest corner, looking southeast.
